SSN-151-103  
(11) 24 November 1961  
(12) 17 p.

LOCKHEED AIRCRAFT CORPORATION  
Lockheed Missiles and Space Company  
Sunnyvale, California

(6) NASA/AGENA-B RANGER PROGRAM  
LAUNCH PAD DAMAGE REPORT  
for  
ATLAS 117D/AGENA-B 10205-6002  
RANGER SPACECRAFT RA-2  
COMPLEX 12, AMR.

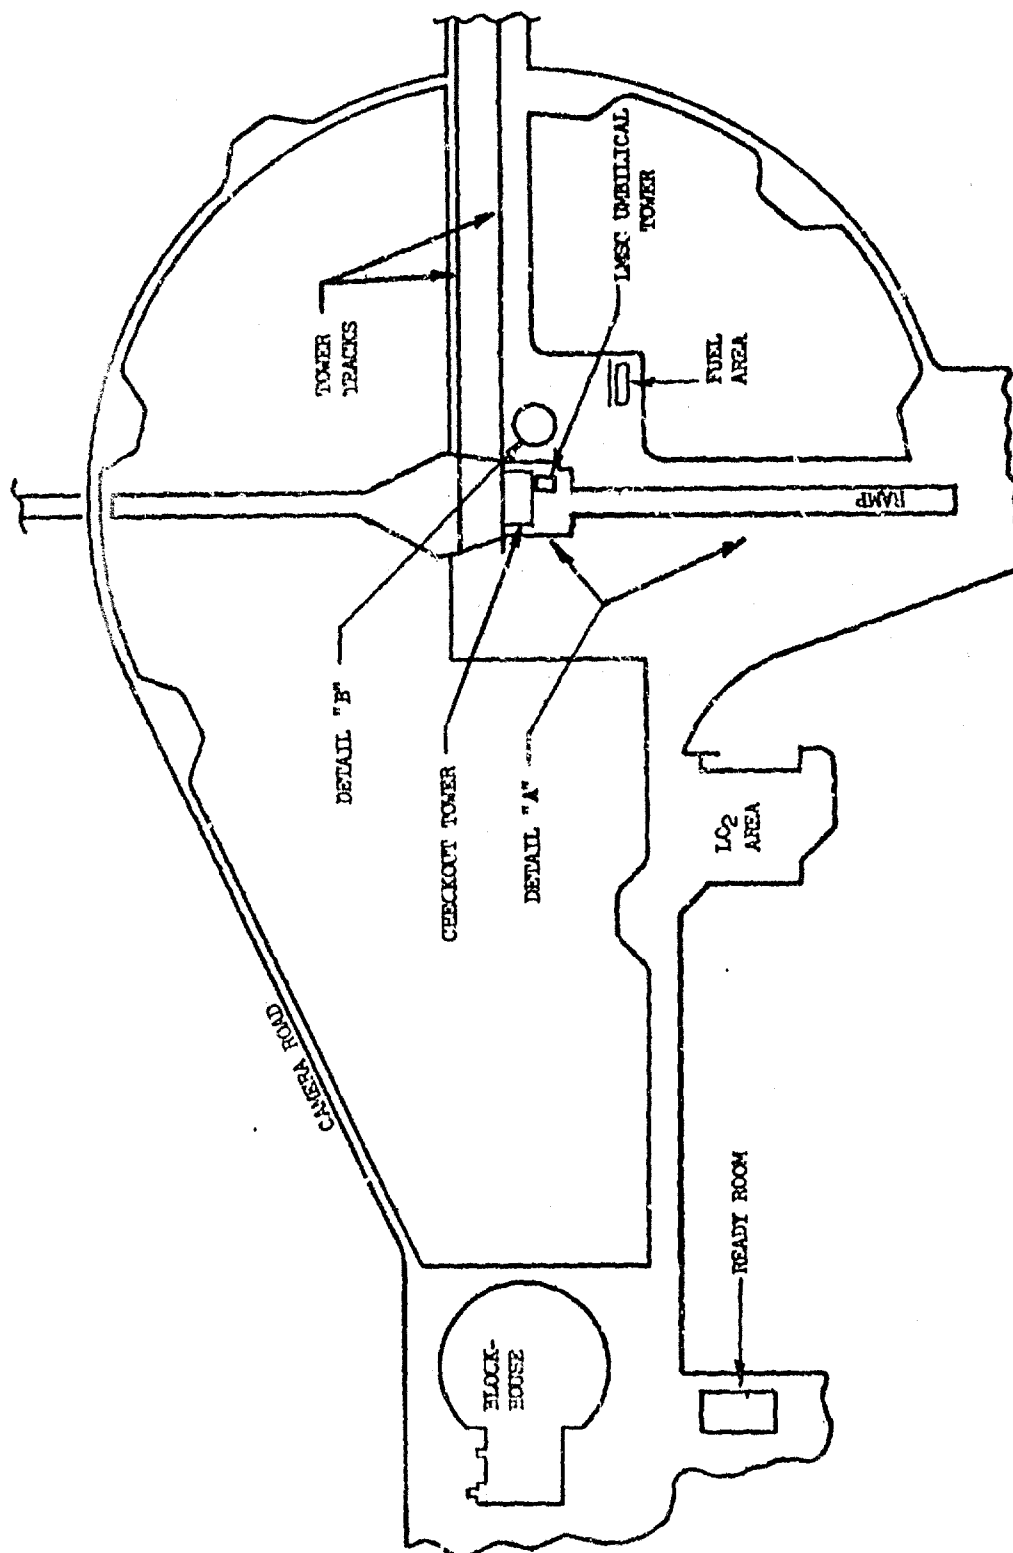
Figure 2-1. Major AGE Components, Complex 12

Figure 2-1 presents an overall view of Complex 12 and location of major AGE components. Figure 2-2, Detail "A", indicates the location of GD-A components relative to the launch area. Figure 2-2, Detail "B", shows the location of LMSC components in relation to the launch area.
